**Flood Control Project Maintenance
Levee Inspections**

Fall 2009 Levee Maintenance Deficiency Summary Report

San Joaquin River Basin

Madera County FCWCA

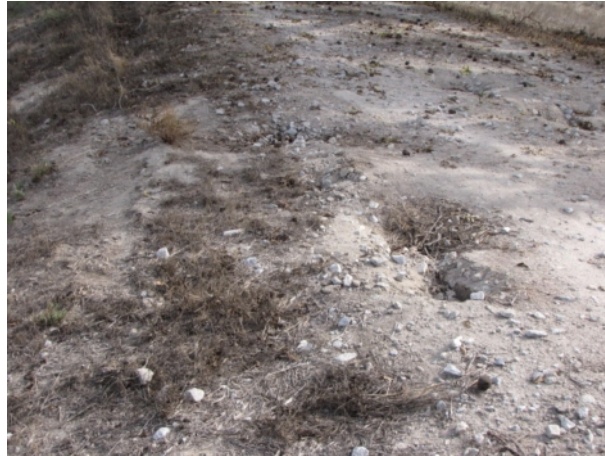
phillips_20091125_8.jpg

Levee Mile Report Line	10
Start Levee Mile	1.50
End Levee Mile	1.53
Location	Crown
Category	Earthen Levee
Item	Animal Control

There are several rodent holes in the shoulder and crown of the road way.

10	1.50	1.53	Earthen Levee	Animal Control	CR	M	Exterminate rodents and backfill and compact or grout burrows. Inspector Comments: At this levee section levee mile 1.50 I measured a section of levee in that area there were 15 holes on the water side 4 in the crown road way and 3 on the land side. Pictures taken.	36.996550 ° -120.347108 °	36.996583 ° -120.346683 °	8 Y
11	1.50	1.53	Earthen Levee	Animal Control	WS	M	Exterminate rodents and backfill and compact or grout burrows.	36.996557 ° -120.347102 °	36.996583 ° -120.346678 °	9

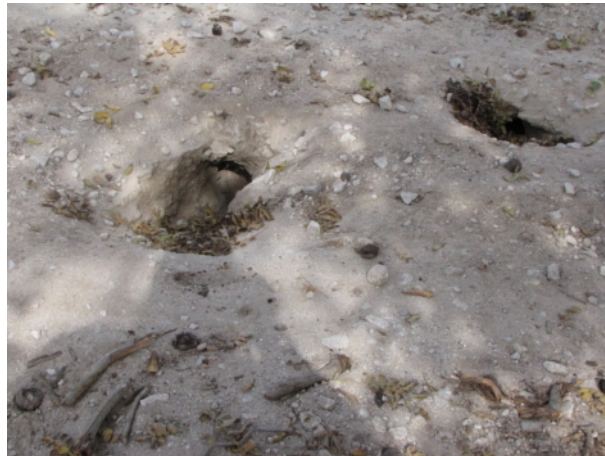
phillips_20091125_9.jpg

Levee Mile Report Line	10
Start Levee Mile	1.50
End Levee Mile	1.53
Location	Crown
Category	Earthen Levee
Item	Animal Control

This photo show holes in crown and shoulder.

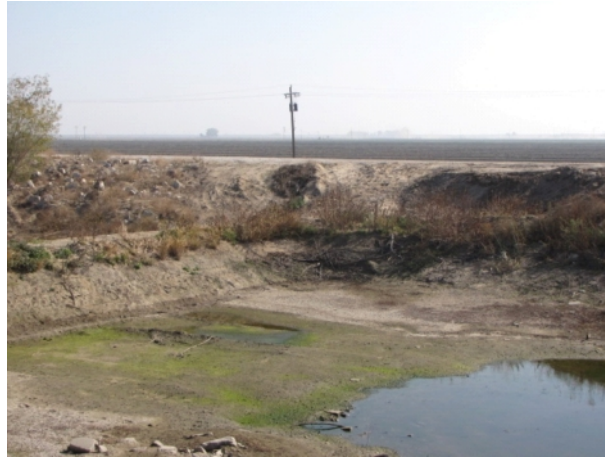
phillips_20091125_7.jpg

12	6.65	6.65	Earthen Levee	Encroachments	WS	U	Material Inspector Comments: Here at location is a earthen Dam operated by MID. This Dam should have been Taken out 11-01 the beginning of flood season. Levee mile 6.57 5-foot high 70-75-foot across from right bank to left bank. 36.968493-120.255125. Three photos taken.	36.968493 ° -120.255205 °	36.968493 ° -120.255205 °	28 Y
13	6.66	6.82	Earthen Levee	Animal Control	LS	C	No rodents visible, but rodent burrows visible; need to backfill and compact or grout borrows.	36.968520 ° -120.255100 °	36.969223 ° -120.252502 °	10
14	6.90	6.95	Earthen Levee	Animal Control	LS	C	No rodents visible, but rodent burrows visible; need to backfill and compact or grout borrows.	36.969513 ° -120.251047 °	36.969540 ° -120.250192 °	11
15	7.61	7.76	Earthen Levee	Animal Control	LS	M	No rodents visible, but rodent burrows visible; need to backfill and compact or grout borrows.	36.969577 ° -120.238330 °	36.969725 ° -120.235783 °	12

Levee Mile Report Line	12
Start Levee Mile	6.65
End Levee Mile	6.65
Location	Water Side
Category	Earthen Levee
Item	Encroachments

This earthen dam was constructed by MID and during this inspection it should have taken out before Nov.1 2009 the start of flood season. Madera County has contacted MID and instructed them to remove structure.
